Welcome All Park Multi-Purpose Facility Partial Roof Replacement & Skylight Repair

Addendum No. 3

**ROOF SAMPLING AND ANALYSIS
WELCOME ALL PARK MULTIPURPOSE FACILITY
4255 WILL LEE ROAD
COLLEGE PARK, GEORGIA 30349**

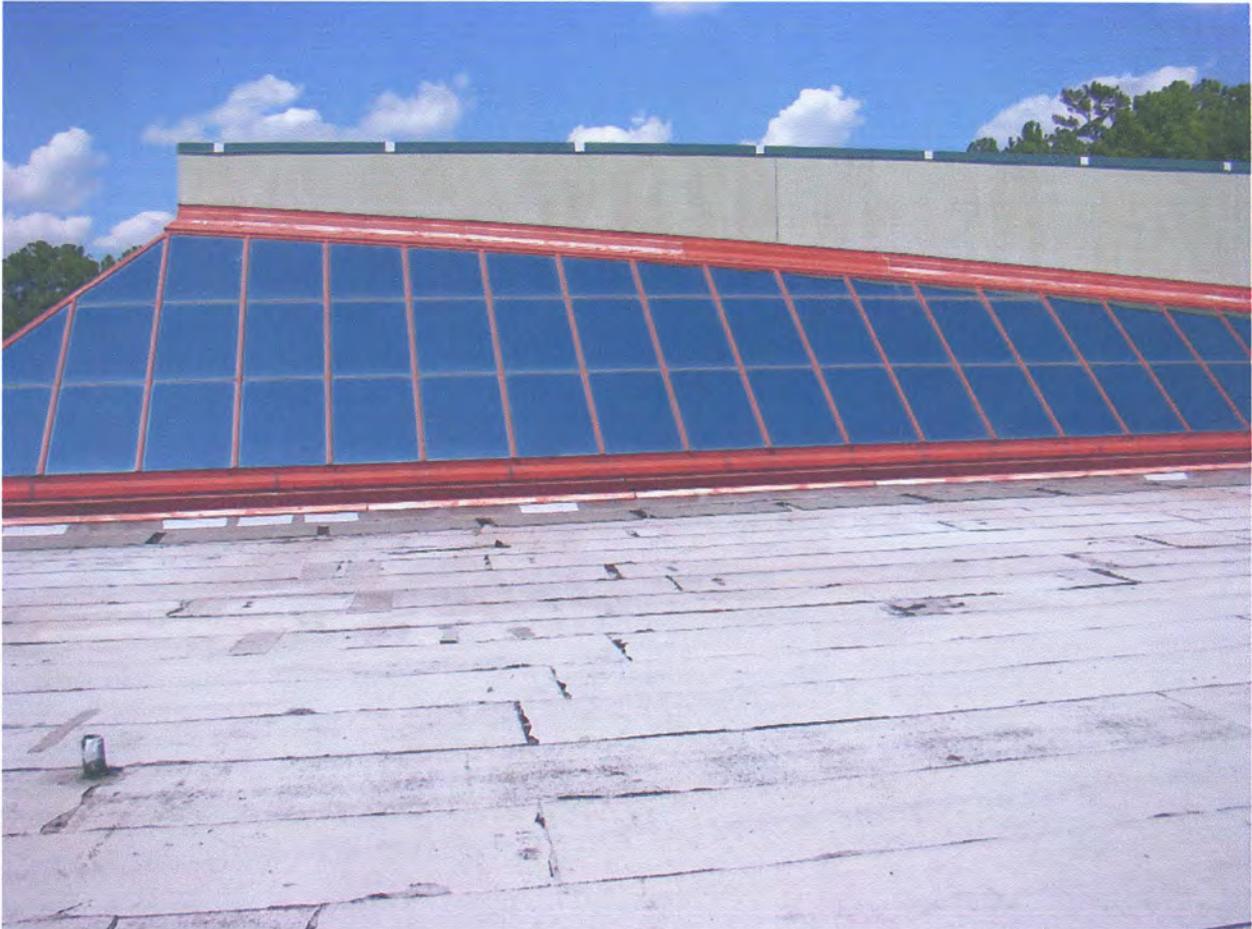
Photograph #	1	REI Project No.	1051.027
Date Taken:	September 12, 2011		
Description of Photograph:	Modified bitumen membrane roof area looking North.		
Address:	4255 Will Lee Road, College Park, Georgia

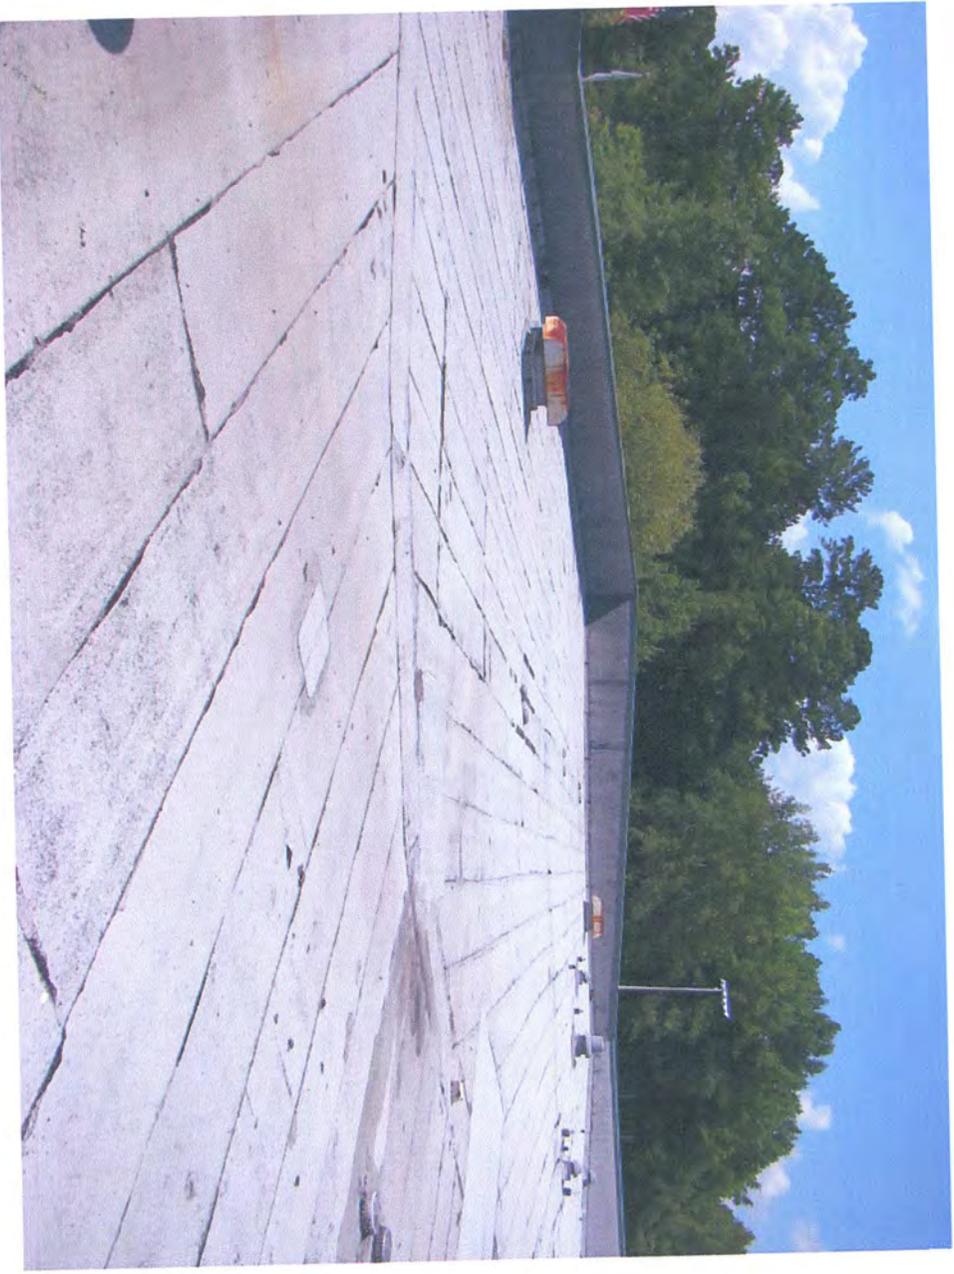
Photograph #	2	REI Project No.	1051.027
Date Taken:	September 12, 2011		
Description of Photograph:	Modified bitumen membrane roof area looking Northwest.		
Address:	4255 Will Lee Road, College Park, Georgia

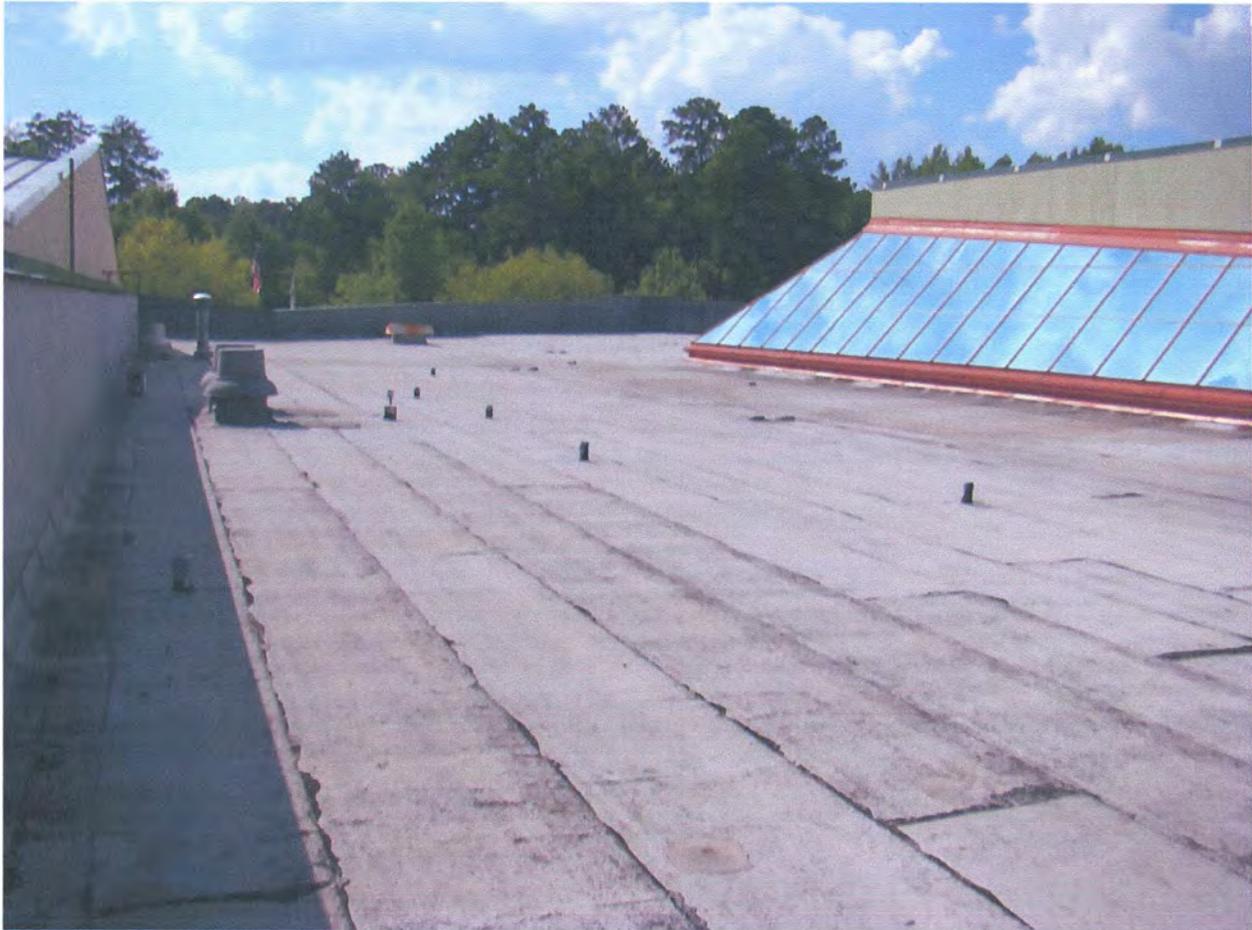
Photograph #	3	REI Project No.	1051.027
Date Taken:	September 12, 2011		
Description of Photograph:	Modified bitumen membrane roof area looking West.		
Address:	4255 Will Lee Road, College Park, Georgia

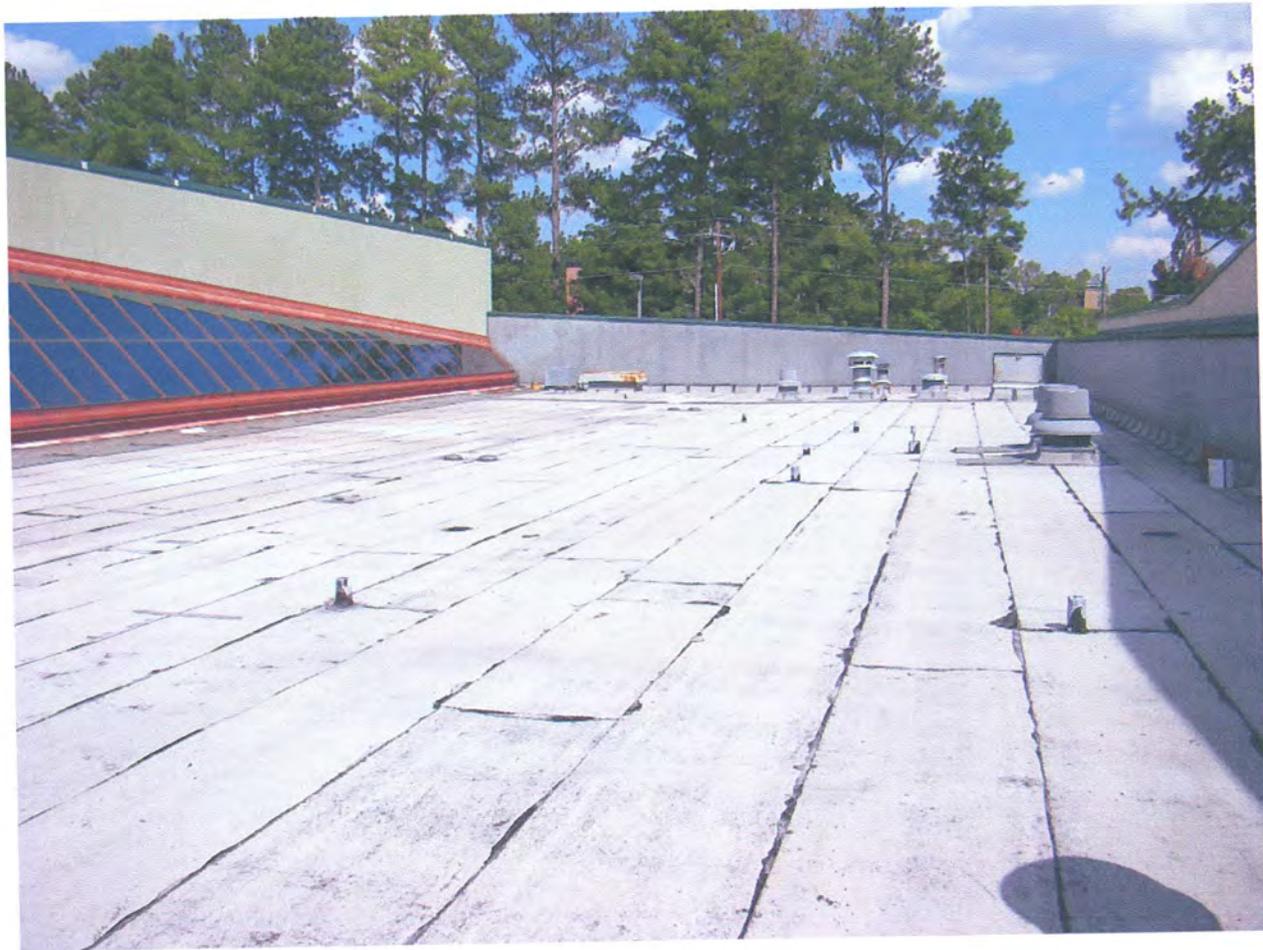
Photograph #	4	REI Project No.	1051.027
Date Taken:	September 12, 2011		
Description of Photograph:	Modified bitumen membrane roof area looking South.		
Address:	4255 Will Lee Road, College Park, Georgia

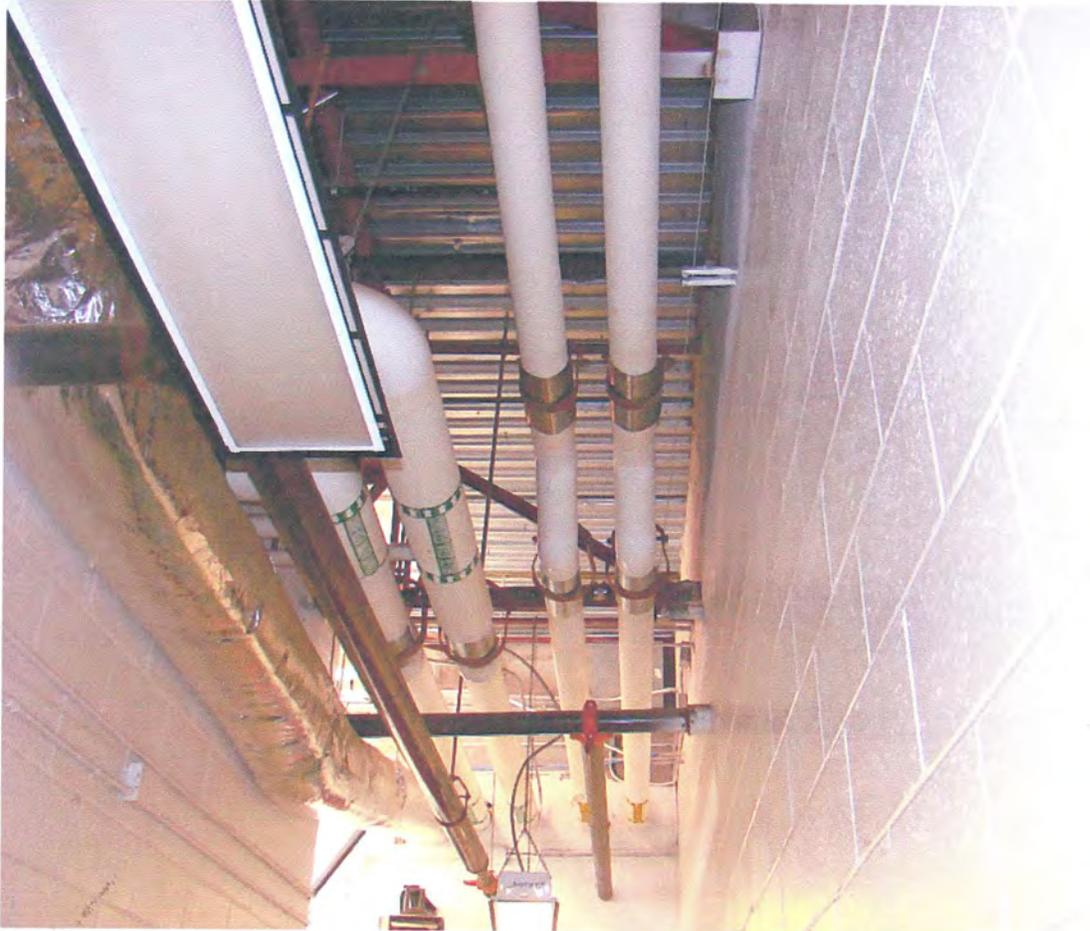
Photograph #	5	REI Project No.	1051.027
Date Taken:	September 12, 2011		
Description of Photograph:	Nominal 1-1/2" deep fluted metal roof deck.		
Address:	4255 Will Lee Road, College Park, Georgia

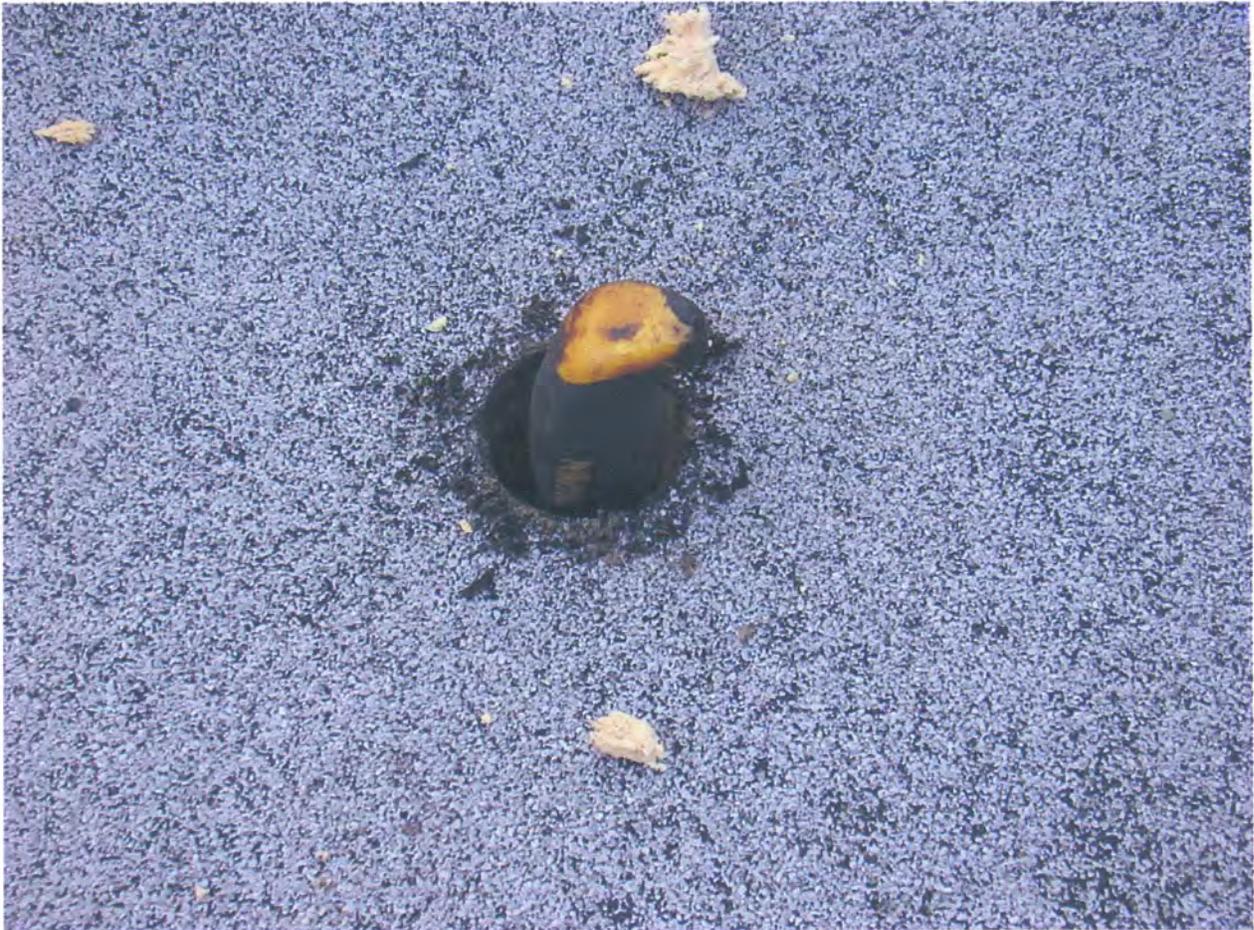
- 4.1. In general, the roof system consists of a granular SBS cap sheet, multiple layers of fiber glass felt, nominal 1/4" per foot tapered mineral perlite and isocyanurate roof insulation on a 1-1/2" fluted metal deck. See Photograph Nos. 1 through 7.
- 4.2. The results of the roof openings were as follows:
 - 4.2.1. Opening No. 1: See aerial photograph at the end of the report for approximate locations. Modified bitumen membrane is fully adhered to the insulation. Tapered roof insulation is nominal 8" thick mineral perlite

insulation over nominal 2" thick isocyanurate insulation. The deck is nominal 1-1/2" deep metal.

Photograph #	6	REI Project No.	1051.027
Date Taken:	September 12, 2011		
Description of Photograph:	Opening No. 1. Modified bitumen membrane roof system over approximately 10" thick tapered insulation.		
Address:	4255 Will Lee Road, College Park, Georgia

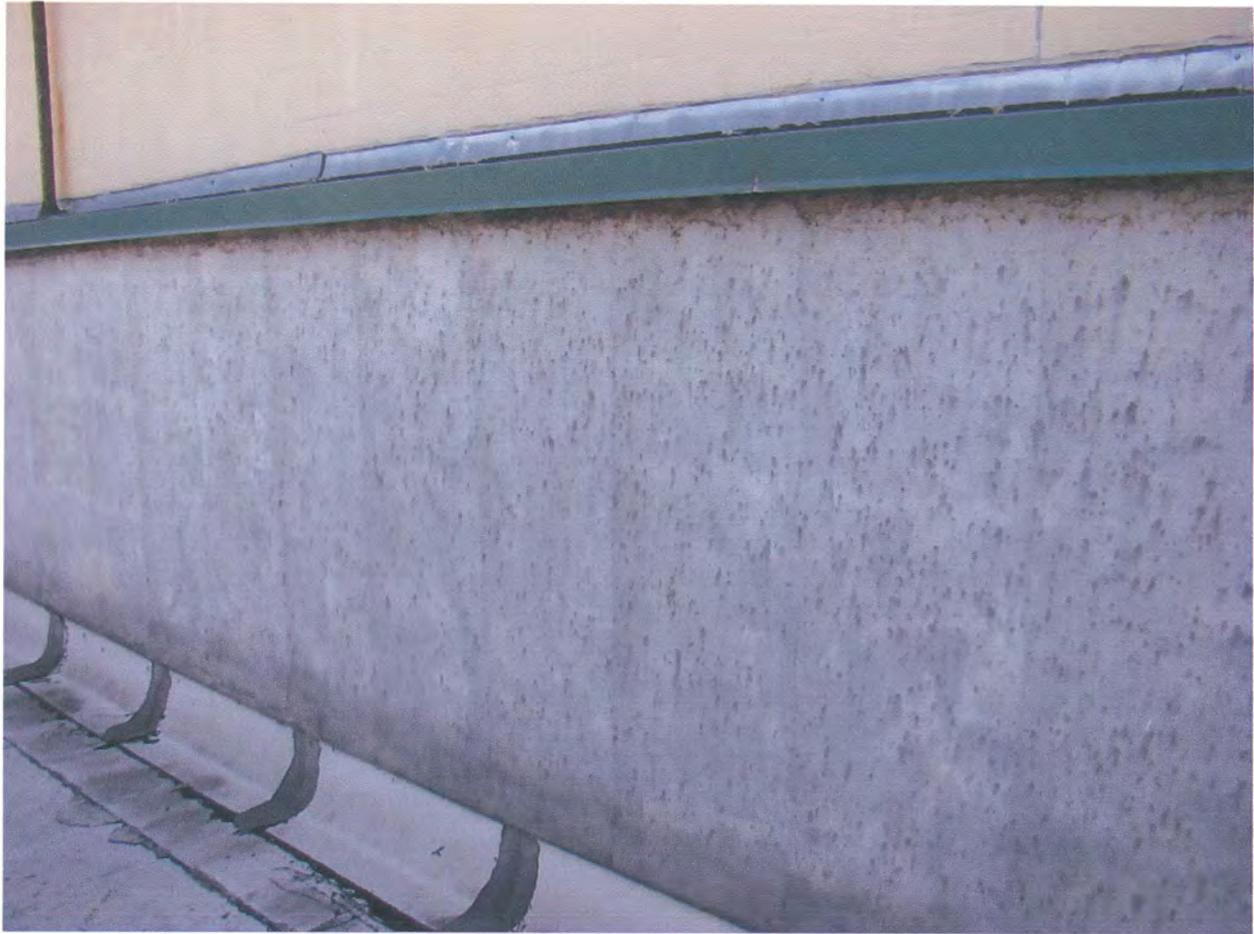
Photograph #	7	REI Project No.	1051.027
Date Taken:	September 12, 2011		
Description of Photograph:	Smooth-surfaced modified bitumen membrane wall flashings.		
Address:	4255 Will Lee Road, College Park, Georgia
