Re: **#11ITB78822K-JD-Carnes Justice Center Building Wall Panel Evaluation Part II**

**#11ITB78822K-JD-Carnes Justice Center Building Wall Panel Evaluation Part II**  
**Addendum No. 5**  
**Page Two**

**ATTACHMENT A**  
**ROOF SAMPLING AND ANALYSIS REPORT**

**ROOF SAMPLING AND ANALYSIS  
CARNES JUSTICE BUILDING  
160 PRYOR STREET  
ATLANTA, GEORGIA 30303**

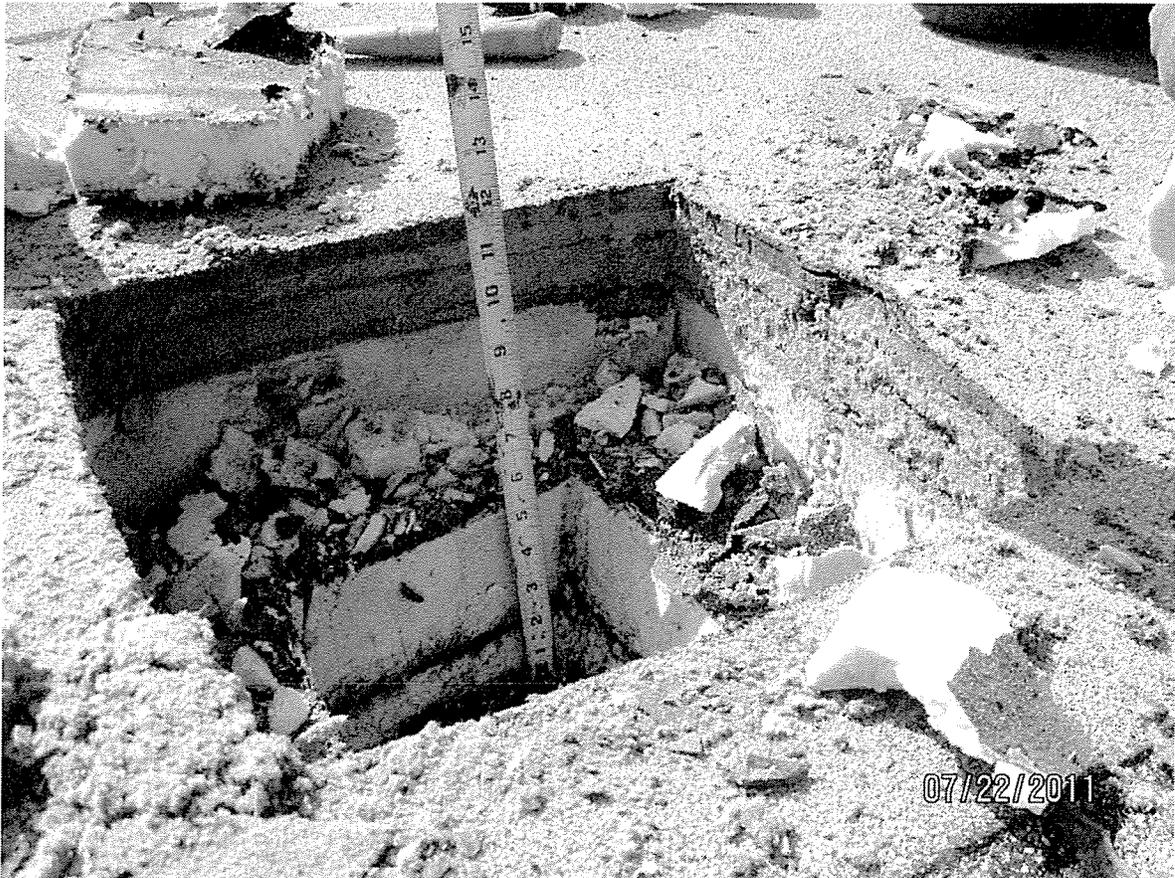
- 5.1.1. Opening No. 1: Located on the upper roof at a ridge approximately 36 feet from the south wall and 53 feet from the east wall. Membrane is fully adhered to the insulation. Roof insulation is nominal 2" thick mineral perlite and is dry to the touch. Isocyanurate roof insulation is nominal 8" thick and was mainly dry to the touch. A small area was wet to the touch. Delmorst reading of 46.5 on the concrete deck indicated a sufficiently dry moisture level. See Photograph Nos. 1 – 3.

Photograph #	1	REI Project No.	1290.001
Date Taken:	July 22, 2011		
Description of Photograph:	Opening No. 1.		
Address:	160 Pryor Street, Atlanta, Georgia

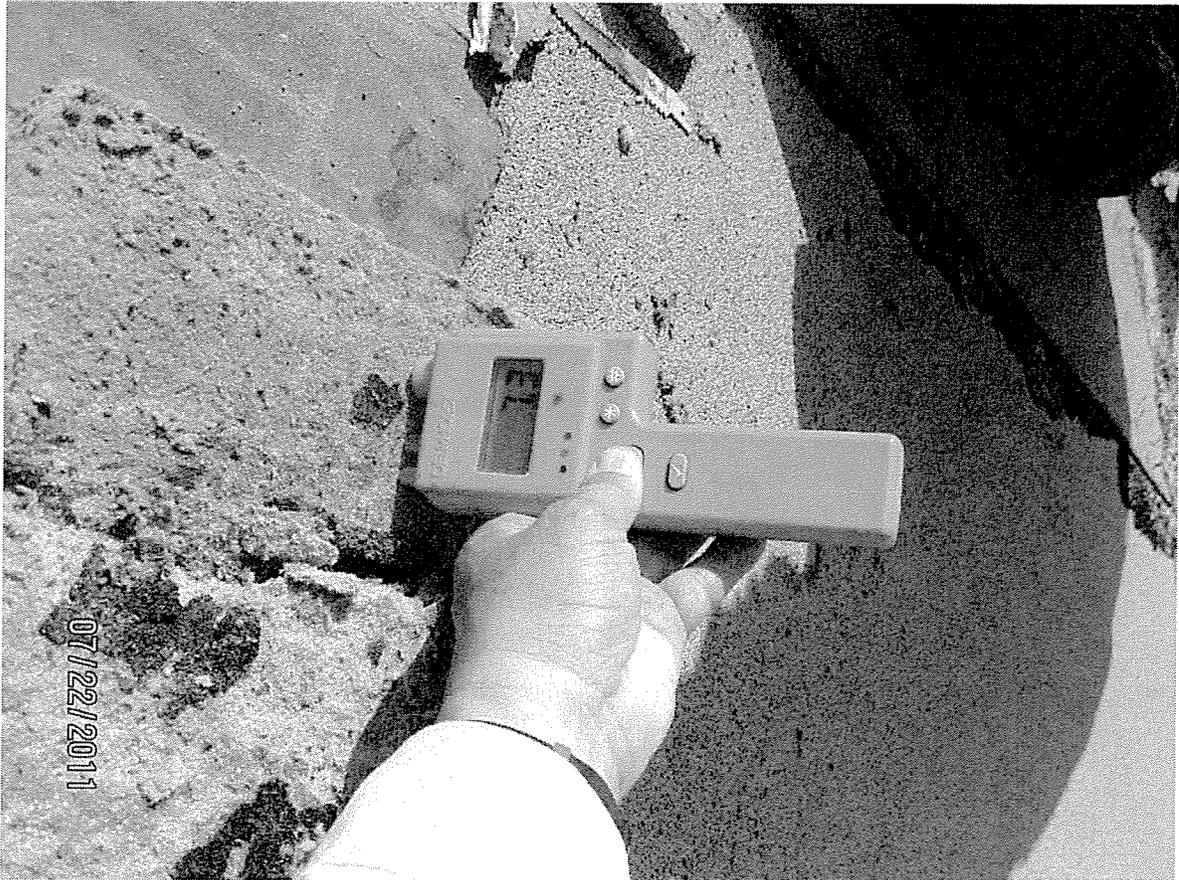
Photograph #	2	REI Project No.	1290.001
Date Taken:	July 22, 2011		
Description of Photograph:	Opening No. 1. Delmhorst reading of mineral perlite is 7.3.		
Address:	160 Pryor Street, Atlanta, Georgia

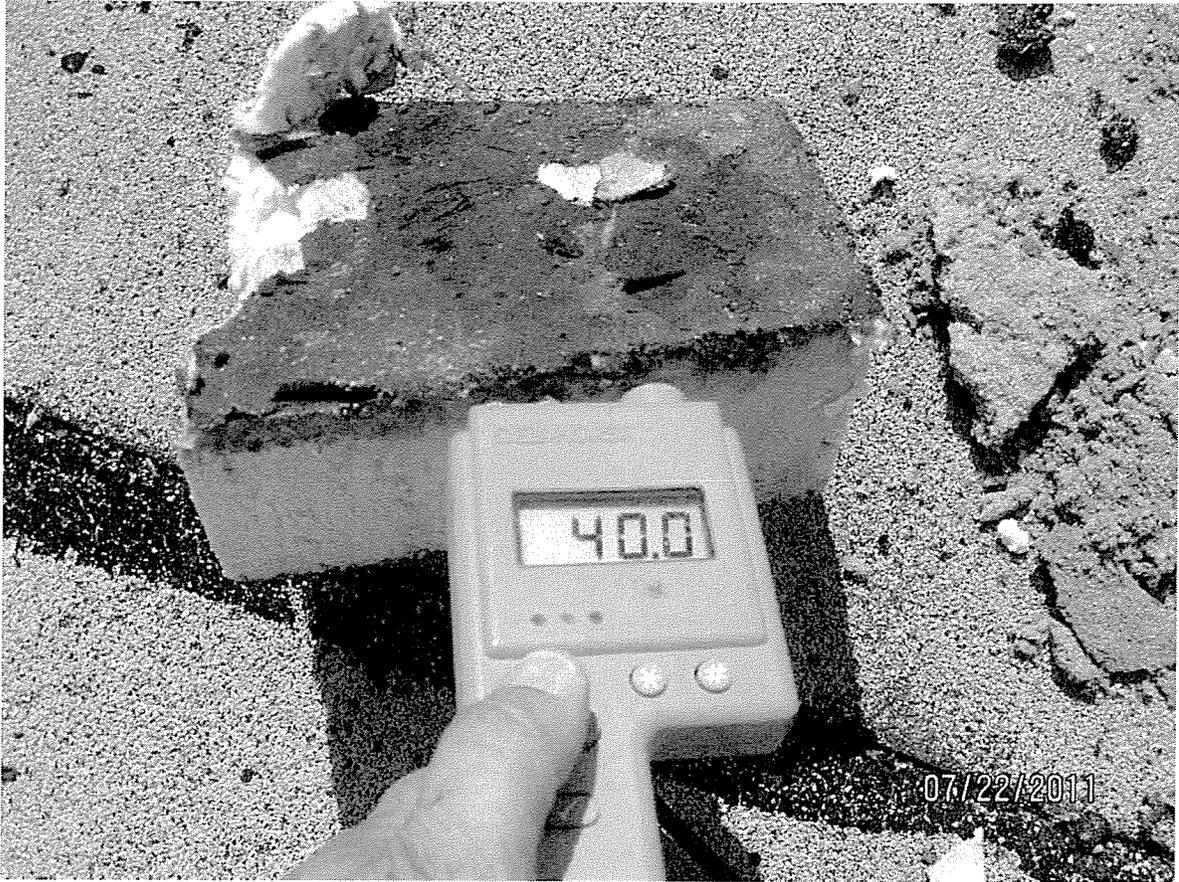
Photograph #	3	REI Project No.	1290.001
Date Taken:	July 22, 2011		
Description of Photograph:	Opening No. 1. Delmhorst reading of isocyanurate roof insulation is 40.		
Address:	160 Pryor Street, Atlanta, Georgia

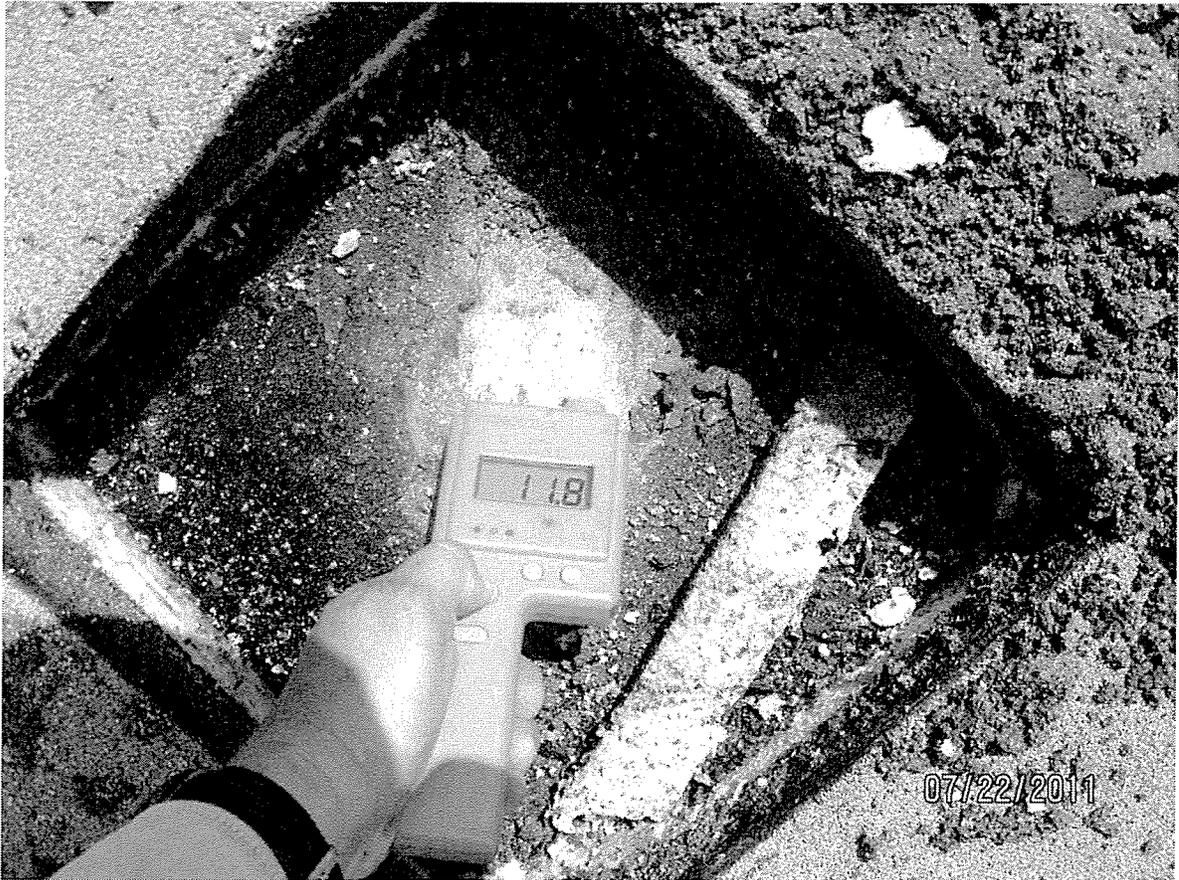
- 5.1.2. Opening No. 2: Located on the upper roof at a valley approximately 16 feet from the south wall and 26 feet from the west wall. Membrane is fully adhered to the insulation. Roof insulation is nominal 1-1/4" thick mineral perlite and is wet to the touch. Isocyanurate roof insulation is nominal 1-1/2" thick and is wet to the touch. Delmorst reading of 11.8 on the concrete deck measured no significant amount of moisture in the deck. However, there was water between the felt plies on the deck and the isocyanurate insulation. See Photograph Nos. 4 - 8.

Photograph #	4	REI Project No.	1290.001
Date Taken:	July 22, 2011		
Description of Photograph:	Opening No. 2. Delmhorst reading of concrete is 11.8.		
Address:	160 Pryor Street, Atlanta, Georgia

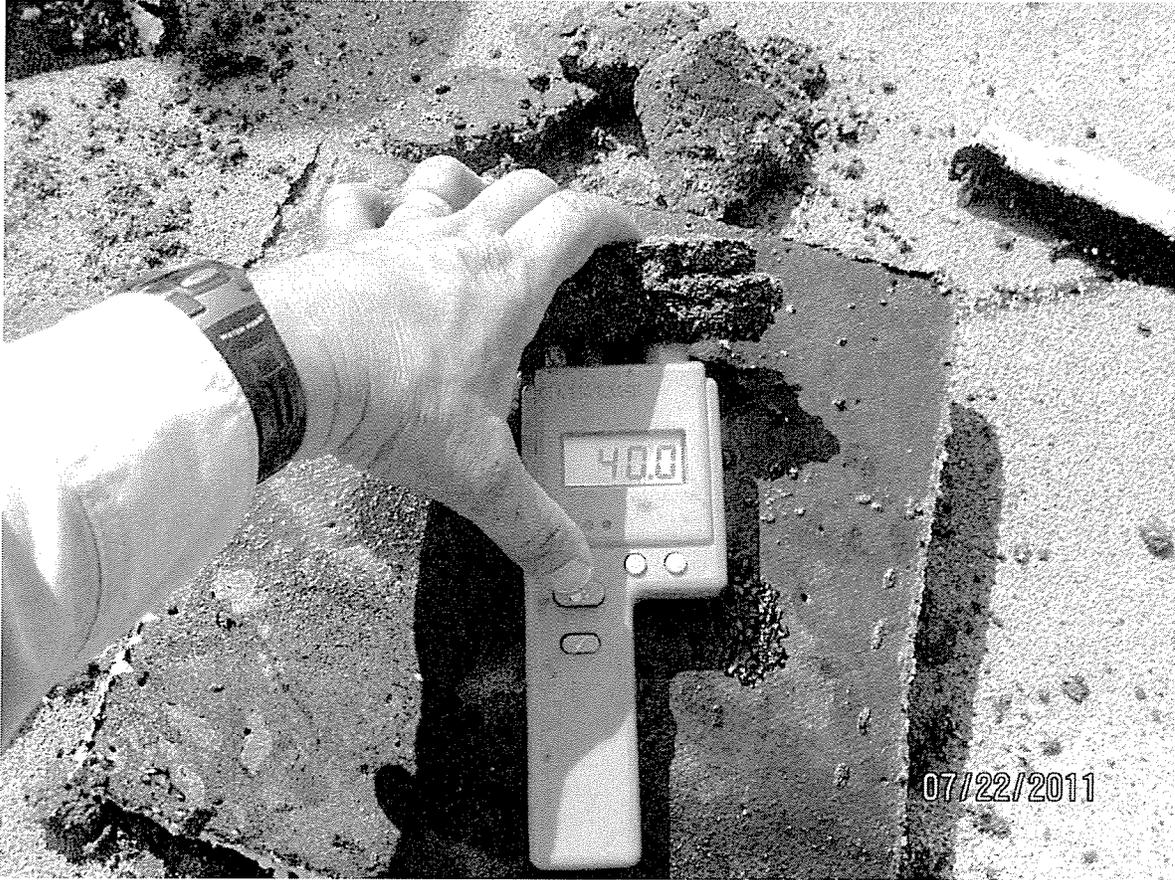
Photograph #	5	REI Project No.	1290.001
Date Taken:	July 22, 2011		
Description of Photograph:	Opening No. 2. Delmhorst reading of mineral perlite is 40.		
Address:	160 Pryor Street, Atlanta, Georgia

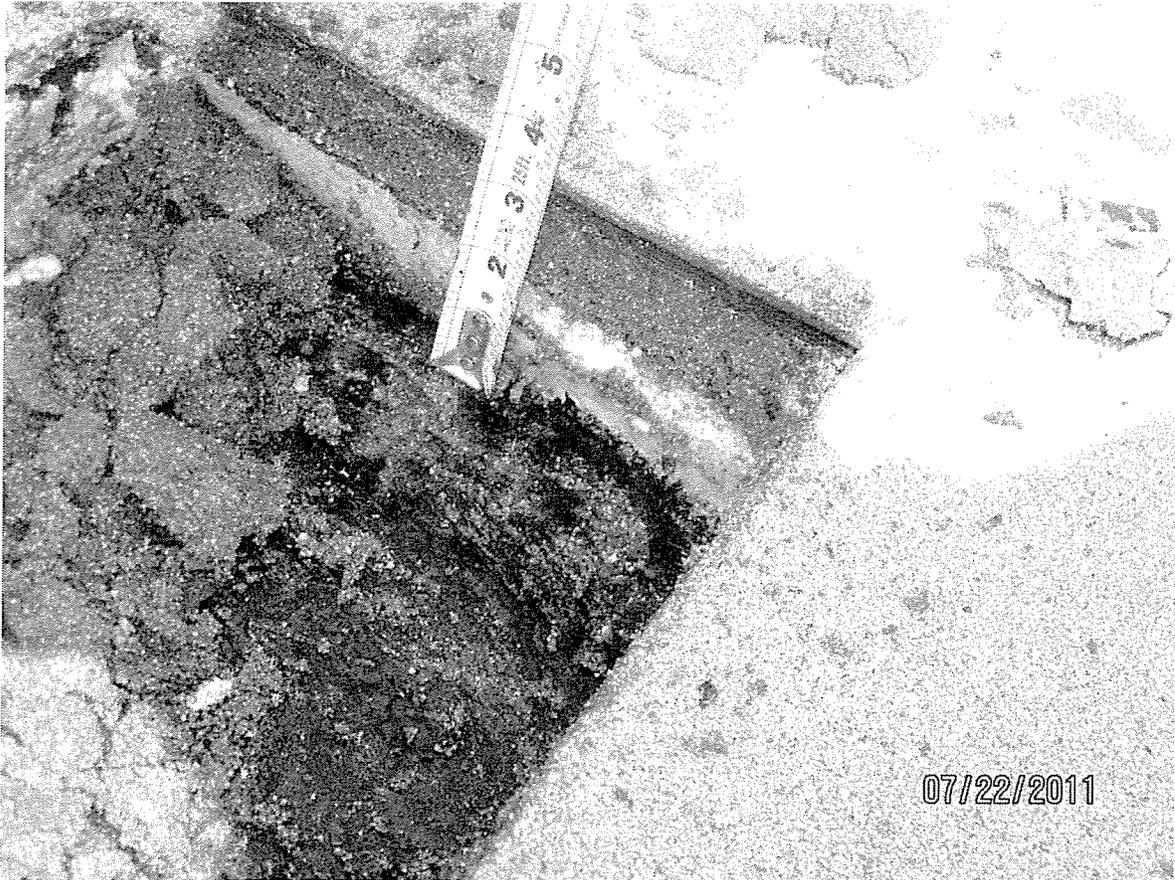
Photograph #	6	REI Project No.	1290.001
Date Taken:	July 22, 2011		
Description of Photograph:	Opening No. 2. Mineral perlite roof insulation is wet to the touch.		
Address:	160 Pryor Street, Atlanta, Georgia

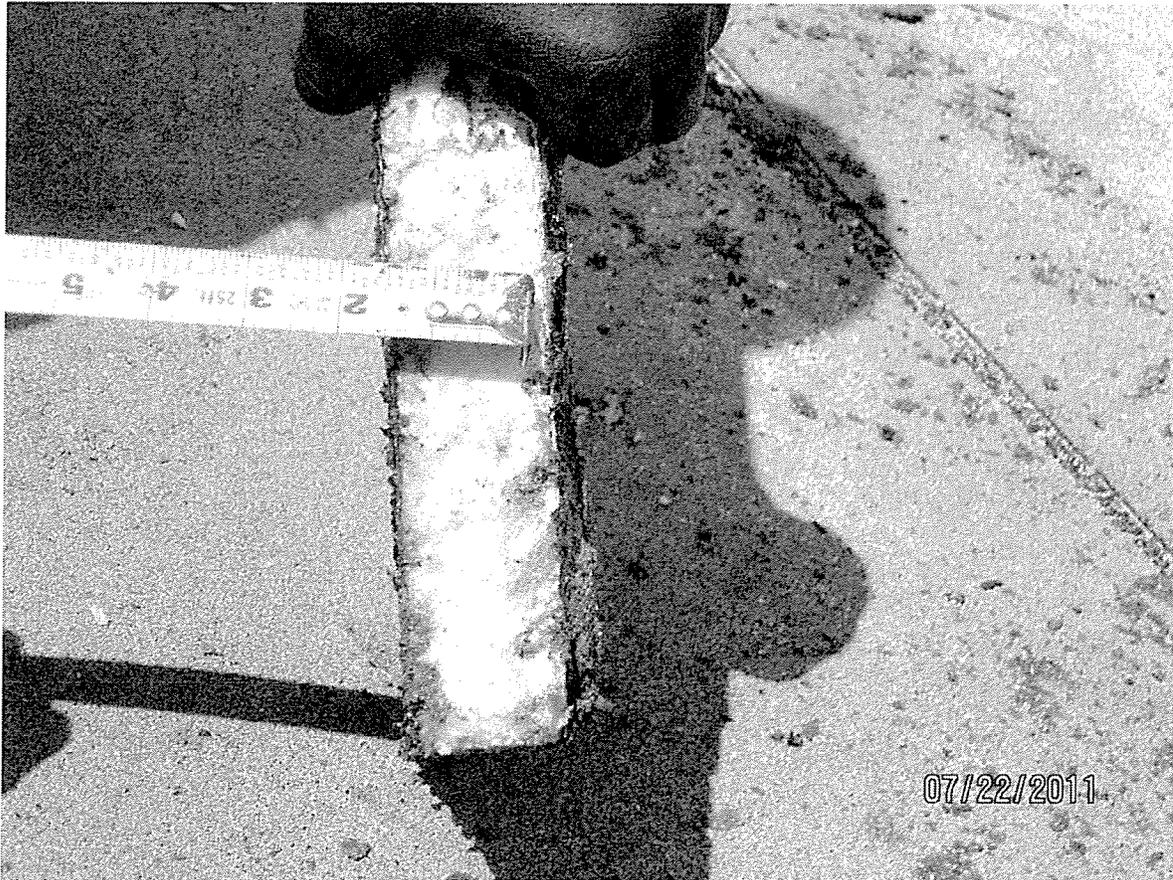
Photograph #	7	REI Project No.	1290.001
Date Taken:	July 22, 2011		
Description of Photograph:	Opening No. 2. Isocyanurate insulation is nominal 1-1/2" thick and is wet to the touch.		
Address:	160 Pryor Street, Atlanta, Georgia

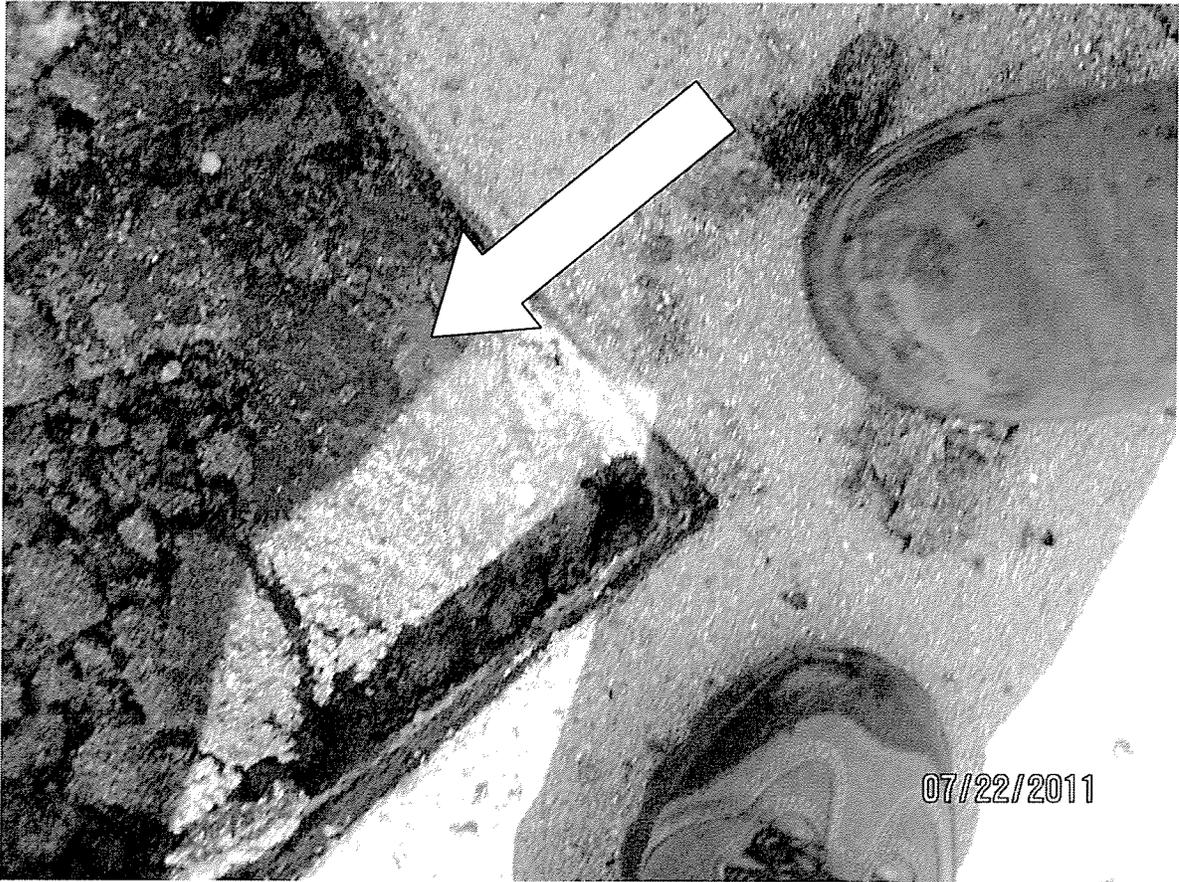
Photograph #	8	REI Project No.	1290.001
Date Taken:	July 22, 2011		
Description of Photograph:	Opening No. 2. Water is visible on the vapor retarder.		
Address:	160 Pryor Street, Atlanta, Georgia

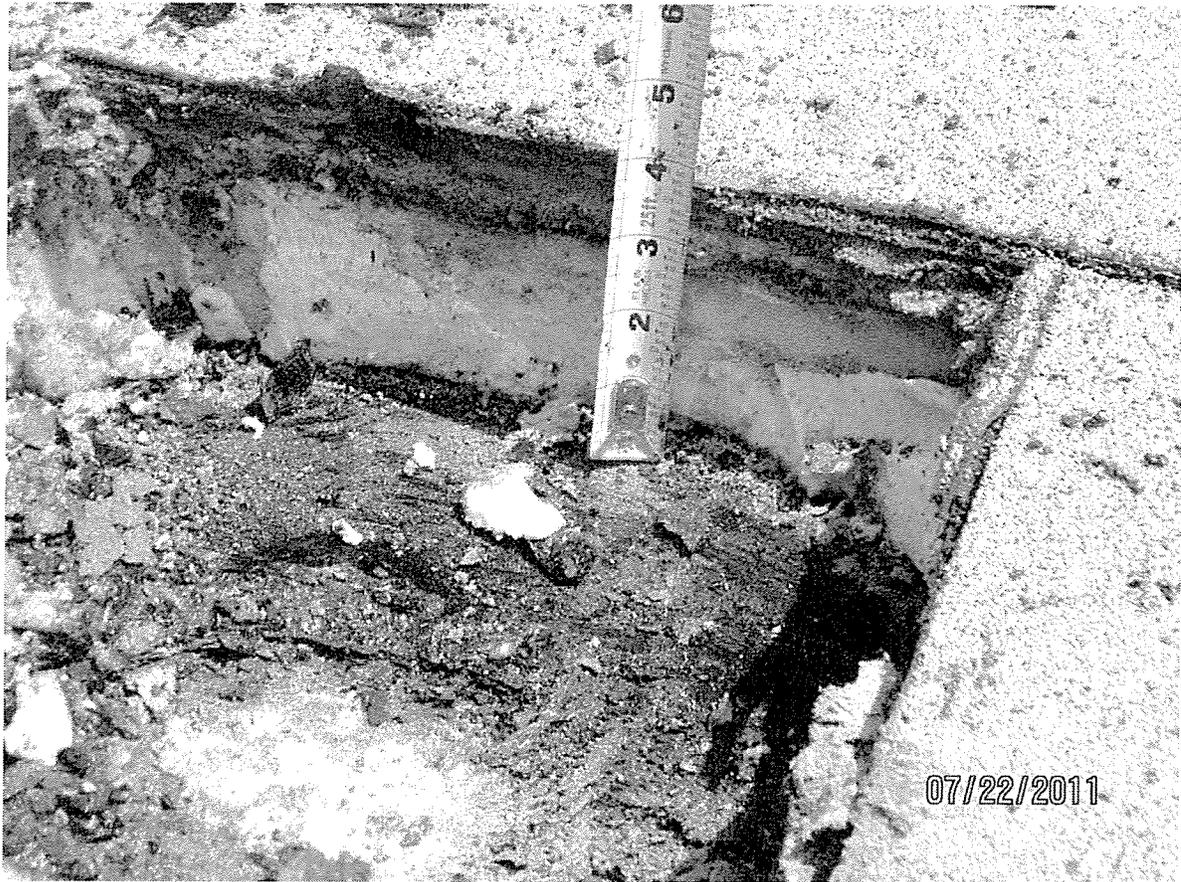
5.1.3. Opening No. 3: Located on the lower roof approximately 8 feet in from the south wall and 23 feet from the east wall. Membrane is fully adhered to the insulation. Roof insulation is nominal 1 1/2" thick mineral perlite and is wet to the touch. Isocyanurate roof insulation is nominal 2-1/2" thick and was wet to the touch. Delmorst reading of 52.4 on the concrete deck measured no significant amount of moisture in the deck. See Photograph Nos. 9 – 12.

Photograph #	9	REI Project No.	1290.001
Date Taken:	July 22, 2011		
Description of Photograph:	Opening No. 3.		
Address:	160 Pryor Street, Atlanta, Georgia

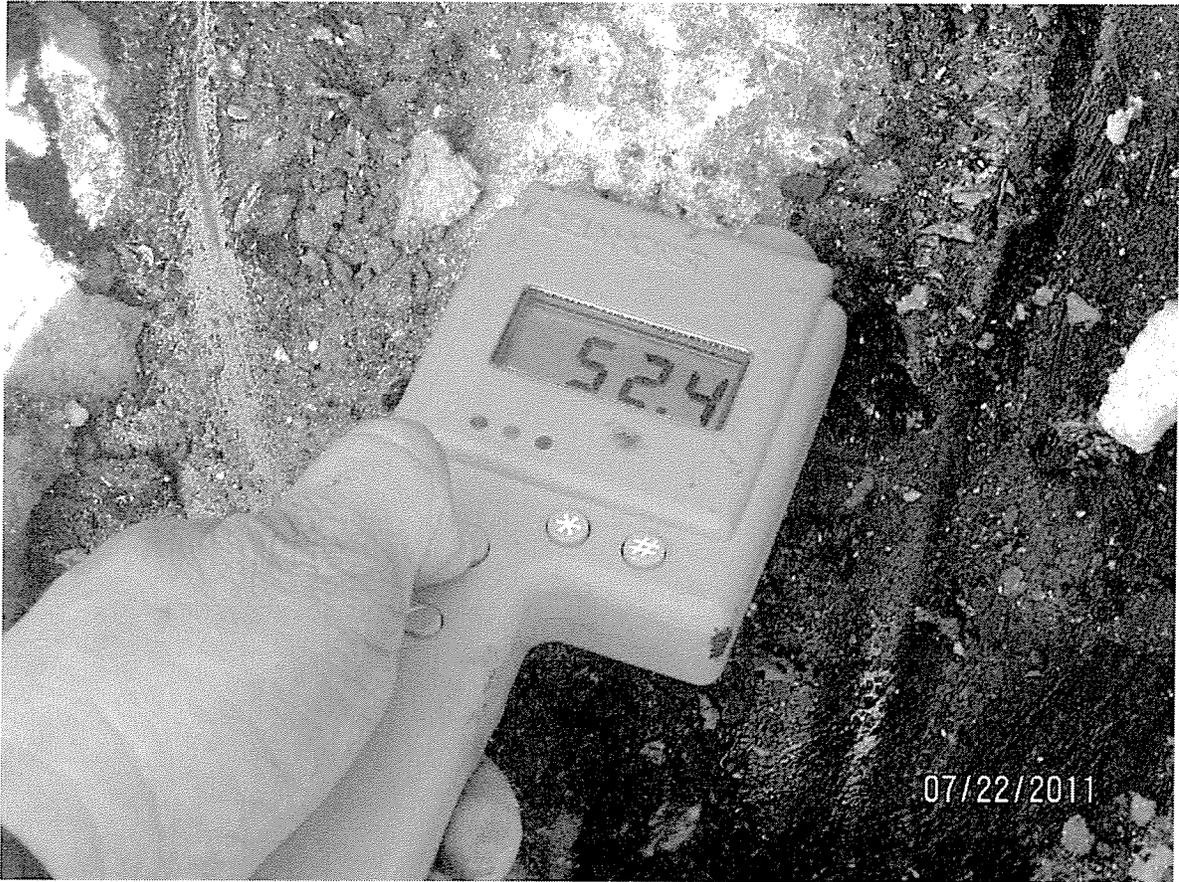
Photograph #	10	REI Project No.	1290.001
Date Taken:	July 22, 2011		
Description of Photograph:	Opening No. 3. Delmhorst reading of concrete is 52.4.		
Address:	160 Pryor Street, Atlanta, Georgia

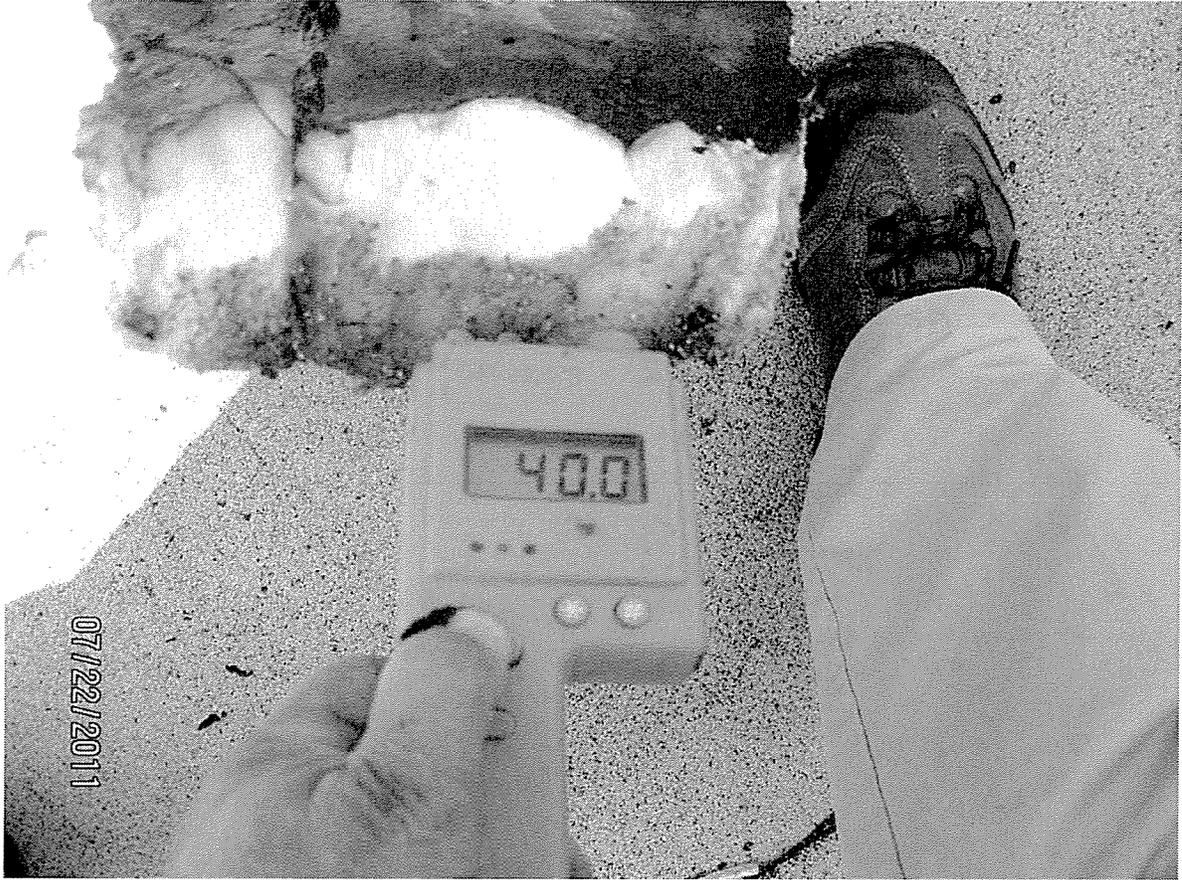
Photograph #	11	REI Project No.	1290.001
Date Taken:	July 22, 2011		
Description of Photograph:	Opening No. 3. Delmhorst reading of isocyanurate insulation is 40.		
Address:	160 Pryor Street, Atlanta, Georgia

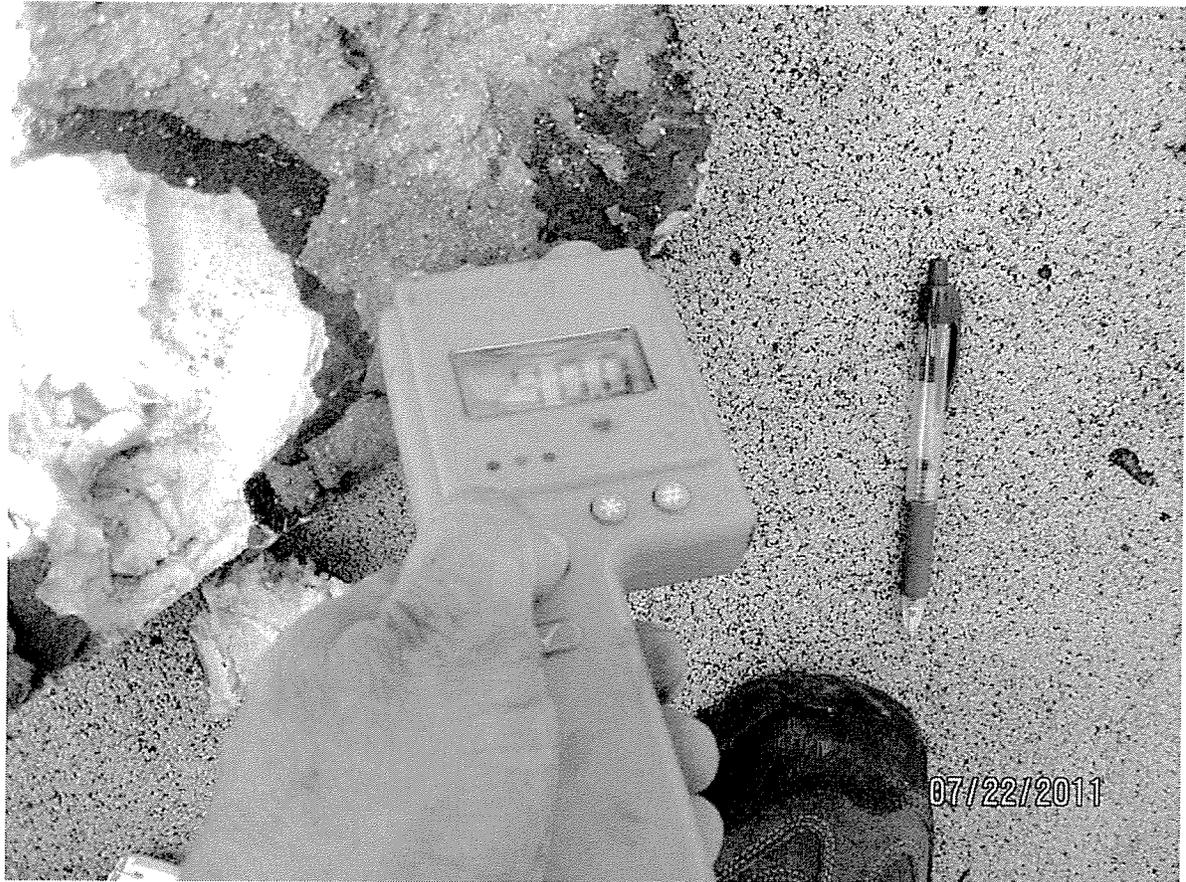
Photograph #	12	REI Project No.	1290.001
Date Taken:	July 22, 2011		
Description of Photograph:	Opening No. 3. Delmhorst reading of mineral perlite is 40.		
Address:	160 Pryor Street, Atlanta, Georgia
